Manhole Inspection Summary

Manhole # S31K__032MH

Insp Date: **12/29/08 11:26 AM**

Location Address: **630 Emory St**

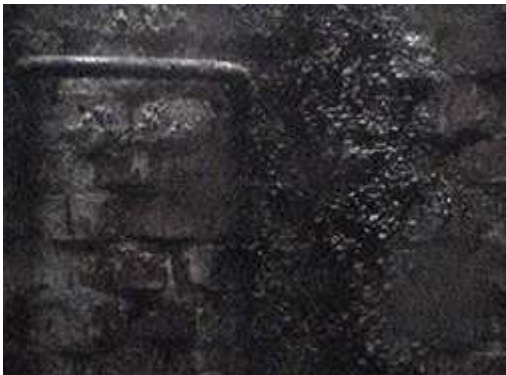
Miscellaneous

corbel infiltration

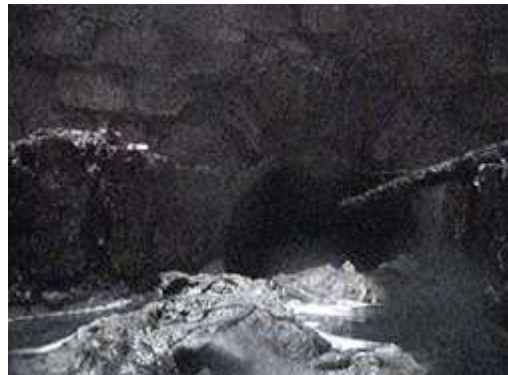
Defect 1

Condition: ☐ Sound ☐ Cracked ☐ Root Intrusion ☐ Deteriorated ☐ Leaks ☒ **Debris**

Channel debris

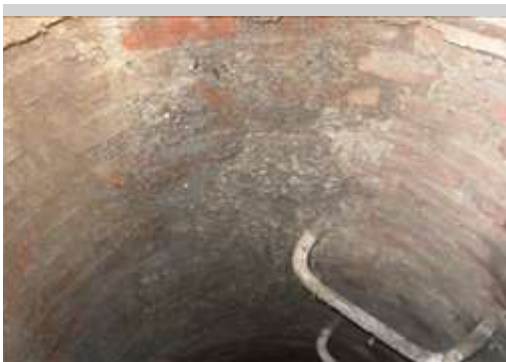
Defect 3

Infiltration: ☐ None ☐ Joint ☐ Cracks ☐ Mortar ☐ Roots ☒ **Wall**

corbel wall infiltration

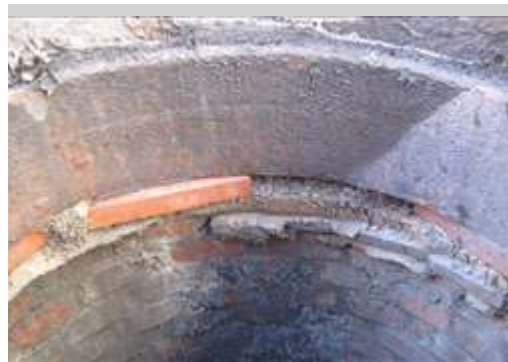
Defect 2

Condition: ☐ Sound ☐ Cracked ☐ Root Intrusion ☒ **Loose Brick** ☐ Deteriorated

Infiltration: ☐ None ☐ Joint ☐ Cracks ☒ **Mortar** ☐ Roots ☒ **Wall**

chimney loose bricks, infiltration at mortar and wall

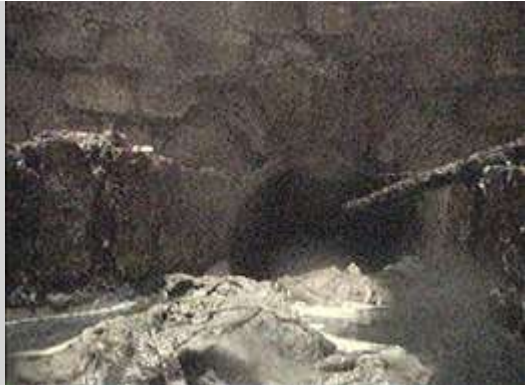
12 O'Clock Outflow

10 in. Circular Gravity Sewer
Pipe Out @ 12 O'Clock

Pipe Height: **10.8** (in.) Rod and Bar (Angled)
Pipe Material: **Clay** ☐ Pipe Lined
Invert Depth: **15.28** (ft.) Flow Characteristics: **Slow**
Deposits: ☒ None ☐ Mud ☐ Sludge ☐ Debris ☐ Grease
Silt Depth: **0** (in.) Deposits Extent:
Infiltration: **None** Pipe Seal Cond: **Sound**

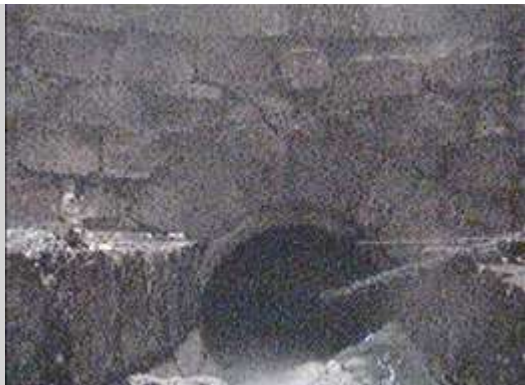
6 O'Clock Inflow

10 in. Circular Gravity Sewer
Pipe In @ 6 O'Clock

Pipe Height: **10.8** (in.) Rod and Bar (Angled)
Pipe Material: **Clay** ☐ Pipe Lined
Invert Depth: **15.27** (ft.) Flow Characteristics: **Fast**
Deposits: ☒ None ☐ Mud ☐ Sludge ☐ Debris ☐ Grease
Silt Depth: **0** (in.) Deposits Extent:
Infiltration: **None** Pipe Seal Cond: **Sound**

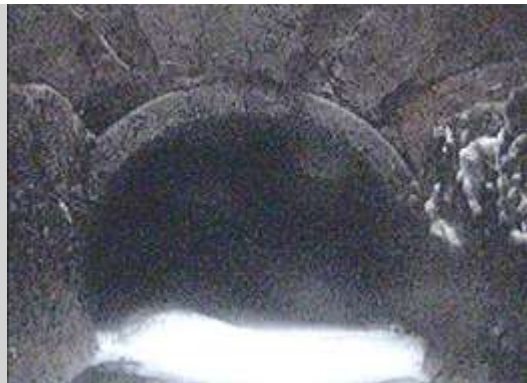
9 O'Clock Inflow

8 in. Circular Gravity Sewer

Pipe In @ 9 O'Clock

Pipe Height: **8.4** (in.) Rod and Bar (Angled)

Invert Depth: **15.08** (ft.) Flow Characteristics: **Slow**

Infiltration: **None** Pipe Seal Cond: **Sound**
